ET1467A

MITSUBISHI (VIRAGE / LANCER) REAR TRAILING ARM BUSH REMOVER / INSTALLER

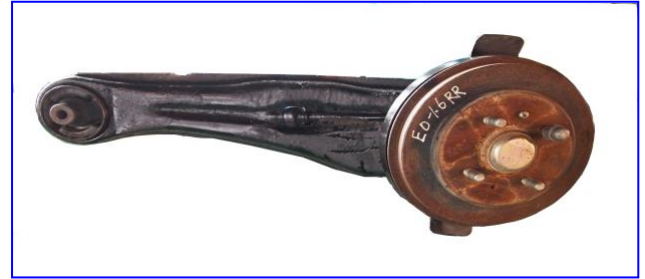
MITSUBISHI LANCER 1.6

- On car maintenance.
- Best tool for replacement of bushes on MITSUBISHI VIRAGE 1.8 and MITSUBISHI LANCER 1.6.
- No damage to ABS sensor cable, trailing arm and parts close to bush during maintenance.
- Fast and easy to use. Save time, within two minutes for removal.
- The window indicator is for reference during removal and installation.
- Application : MITSUBISHI LANCER 1.6(1993 year-2000year), MITSUBISHI VIRAGE 1.8 (2000year~)

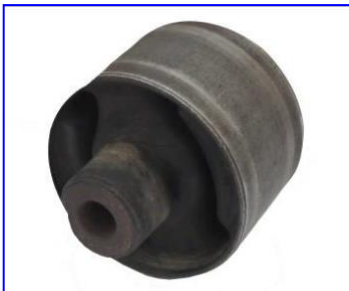
LANCER1.6

Bush number:MR519127

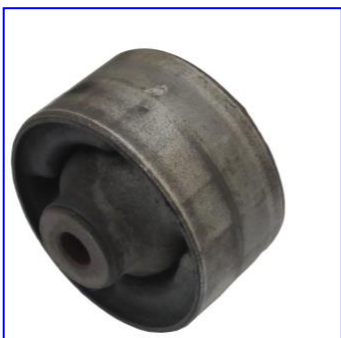
VIRAGE1.8

Bush number:MR102063
