BMW (E81-E88,E90-E93,F2,M3) REAR TRAILING ARM BUSHING REMOVER & INSTALLER **PAT.M459082**

※Application: BMW E81-E88, E90-E93, F2, M3

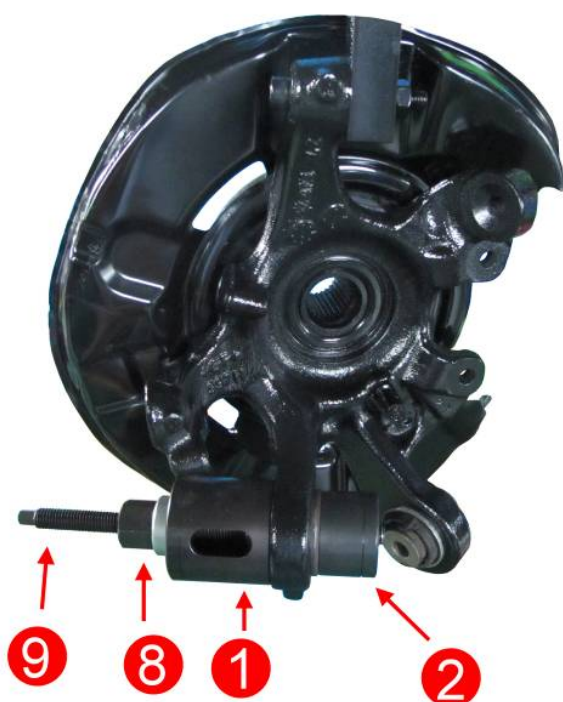
Fig.1

Step 1 : Removing bushing, use No.1.2.8.9 to pull out (Fig.1)

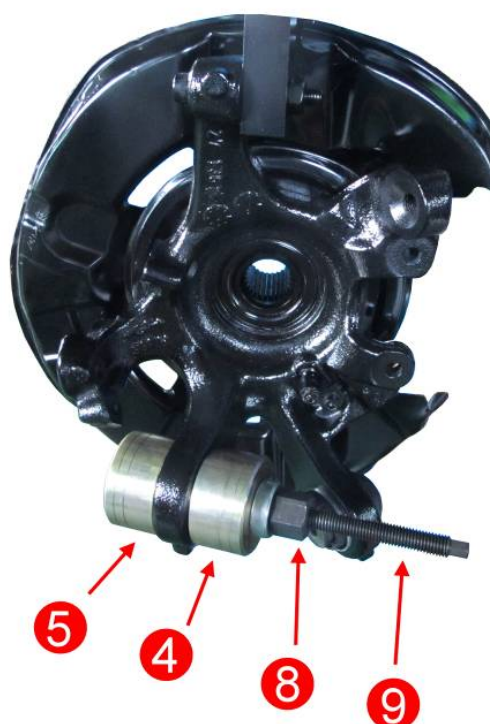
Fig.2

Step 2 : Installing bushing, use No.4.5.8.9. (Fig 2)

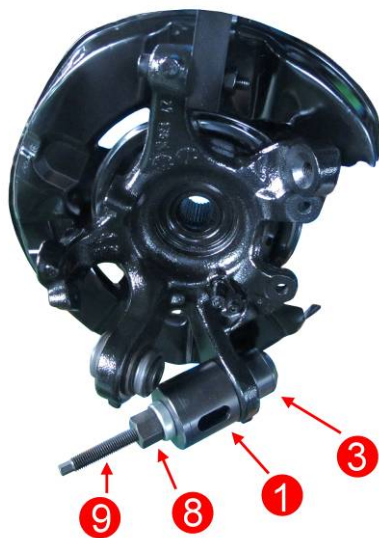
(Fig.1)

Step 1 : **Removing rubber mounting**-Pull out bush with No.1.3.8.9 (Fig 1)

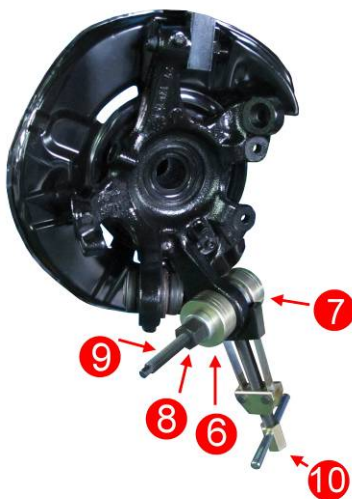
Step 3: Draw rubber mounting with special tools A1487-6, 7, 8, 9 and 10, a little into wheel carrier. (Fig.2)

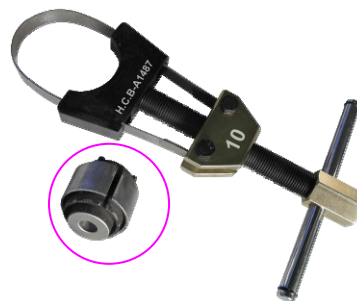
(Fig.3)

※Fit new bush to clamp of No.10. Lubricate thread of T-bar. Tighten the clamp until the bush has come down to a diameter of 45.3mm or less.
